The “Look-See” Crash

Flying an approach to take a look requires the utmost in mental awareness and discipline.

By Wally Roberts

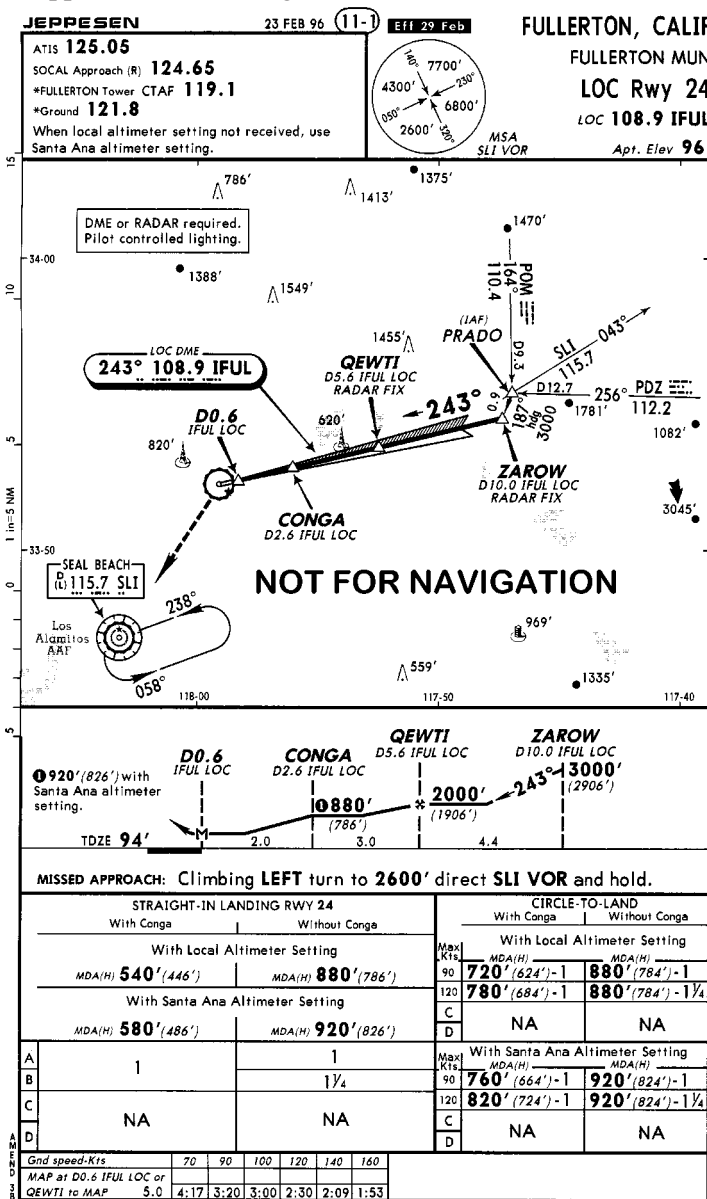
N8JK wasn't DME-equipped. Therefore, the pilots were bound to the higher minimums. Using the Santa Ana altimeter, their MDA should have been 920 feet. The tops of the fog (700-800 feet) were actually below the MDA.

The FUL Localizer Runway 24 approach is a demanding non-precision IAP. The descent gradient from the FAF to touchdown is 381 ft/nm, which is close to the TERPs maximum of 400 ft/nm. There is the added complexity of the application of remote altimeter setting criteria, which apply when the tower is closed. The descent gradient after the Conga step-down fix exceeds TERPs criteria when the remote altimeter setting additive is applied. [(920-94)/2.0 = 413 ft/nm]. (See “Steep Descent Gradient” following this article.)

Note that the altitude before crossing Conga is also the MDA for aircraft without DME. This non-DME MDA is 786 feet HAT when using the local altimeter setting. When the actual flight visibility is at the minimum of 1 sm for Approach Category A, a pilot would be required to maintain the MDA until 1 sm on final approach, because there are no approach lights to reach out and trigger FAR 91.175(c)(3) prior to having one of the runway visual cues in sight.² This translates to a visual segment descent angle of almost 8.5 degrees, a sig-

nificant point often overlooked by pilots and which only comes into play when the weather is at its worst. With the remote altimeter setting, the non-DME descent angle with 1 sm flight visibility is almost 9.0 degrees.

IFR Refresher reported its concerns to the FAA about the excessively steep descent gradient at Conga when using the Santa Ana remote altimeter setting. On July 19, 1996, the FAA issued the following FDC NOTAM in response to our findings: !FDC 6/5040 FUL FI/T FULLERTON MUNI, FULLERTON, CA. LOC RWY 24, AMDT 3B.

ADD NOTES: WHEN SANTA ANA ALSTG USED, INCREASE ALT AT CONGA/I-FUL 2.6 DME 40 FT. WHEN SANTA ANA ALSTG USED, S-24 AND LOC/DME MINIMA S-24 NA.
