GPS, Pilots & ATC

A recent incident reveals many of us need to come up the learning curve before flying GPS approaches.

GPS Approaches: Design & ATC

A lot of rough spots are showing up as GPS standalones proliferate.

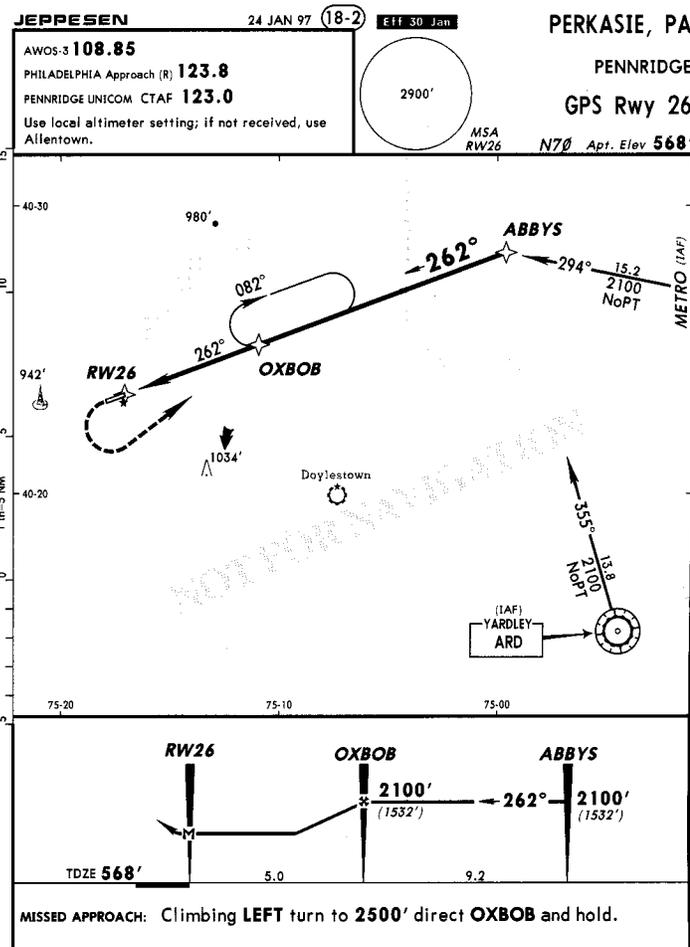
REPRODUCED WITH PERMISSION © JEPPESEN SANDERSON, INC., 1998. ALL RIGHTS RESERVED.

The flight northbound was uneventful. When handed off to Philly Approach, we told the controller we wanted the GPS Runway 26 procedure at Pennridge (on right) and asked to begin the approach at METRO (one of the initial approach fixes for the procedure). "I doubt we'll be able to approve that," replied the controller, "The fix is in New York's airspace and I don't think they'll release it."

that it was all being winged (no pun intended). As you’ll note on the chart, there’s no course reversal authorized at OXBOB; only a missed approach holding pattern. At this location, that might work as a course reversal from a practical standpoint, but it isn’t “codified” and could bite hard somewhere else. Going outbound could have cor

In the process of preparing for this article, I carefully reviewed the instrument approaches into Pennridge. On the GPS Runway 26, both initial approach segments (METRO-ABBYS and ARD-ABBYS) are marked "NoPT," yet there is no published course reversal on the chart. This is incorrect charting convention because

a route marked "NoPT" implies entry into the approach procedure from some directions requires a course reversal. All routes into an approach without a course reversal must meet "NoPT" alignment and descent gradient requirements. Therefore, "NoPT" should never be charted on an approach chart without a course reversal (holding pattern or bold-type holding pattern). I contacted the FAA about this charting error and was told it would soon be
(continued on next page)

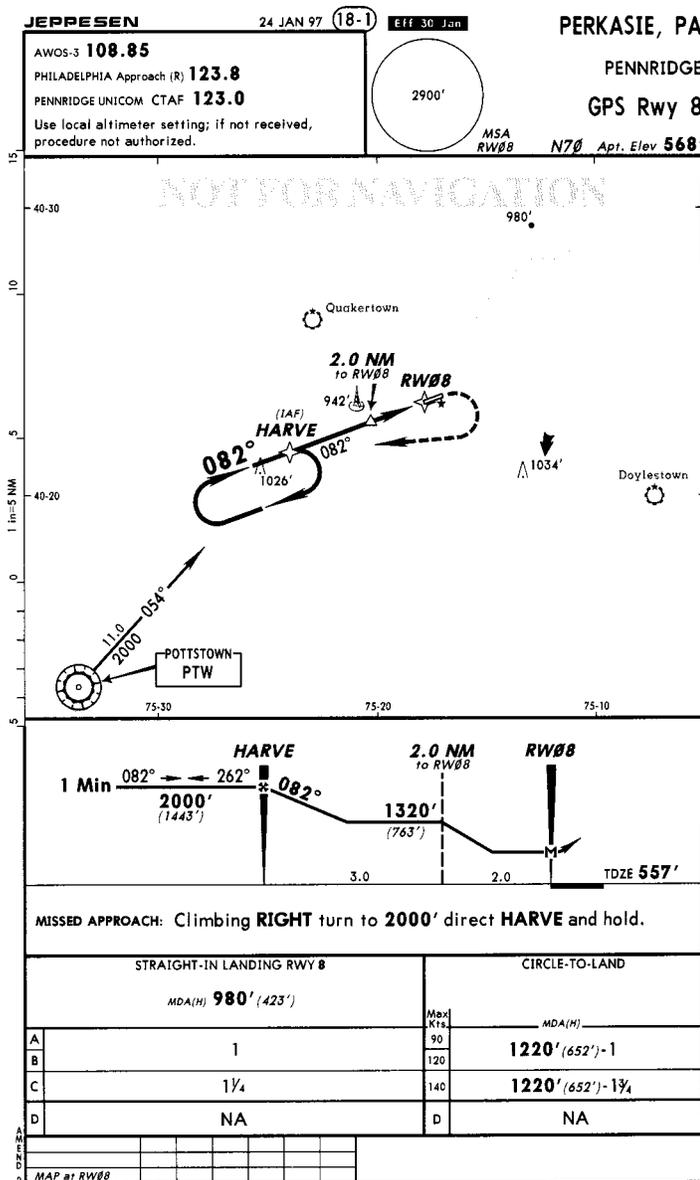
The only feeder route for this procedure is from PTW to HARVE. When proceeding via this route, you must execute the published course reversal at HARVE. The VOR procedure to this runway (see chart page 13) has a “NoPT” route from PTW. Since the airspace has already been evaluated, it wouldn’t be difficult to have a straight-in route for the GPS procedure as well.

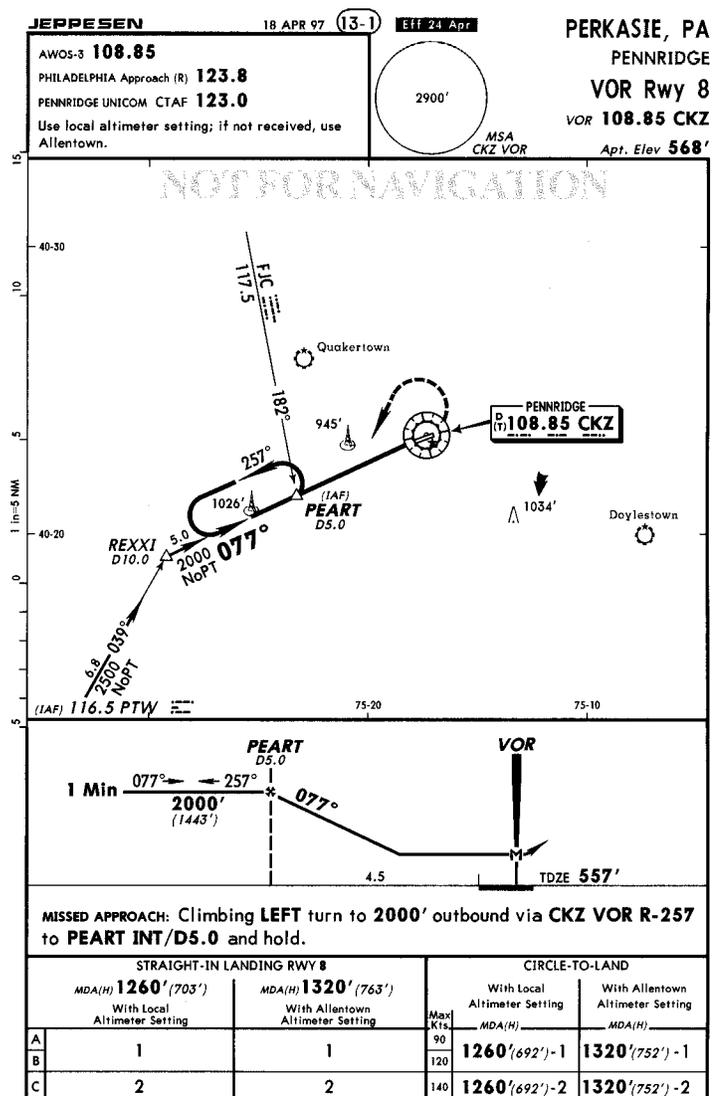
This procedure would have lower minimums if a DME step-down fix was placed inside the FAF, similar to the GPS Rwy 8 procedure shown on page 12. The FAA is presently evaluating the feasibility of adding a step-down fix and lower minimums. The 945-foot tower north of the final approach course is a determining factor.
